VILLAGE OF PORT JEFFERSON EAST BEACH BLUFF STABILIZATION

Village Trustee Meeting: February 22, 2022

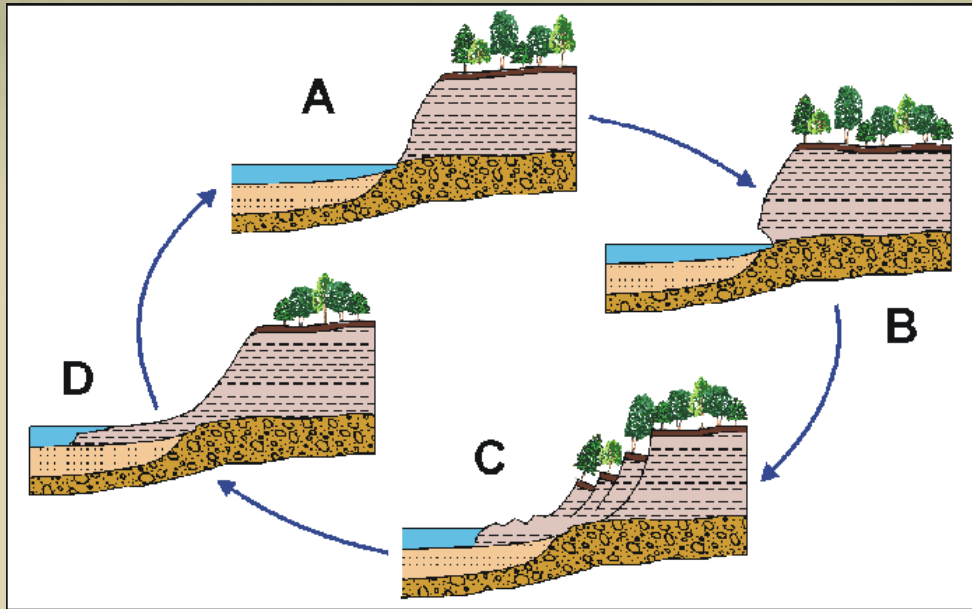
Primary Form of Erosion:
Wave Action at Toe and Bluff Slumping

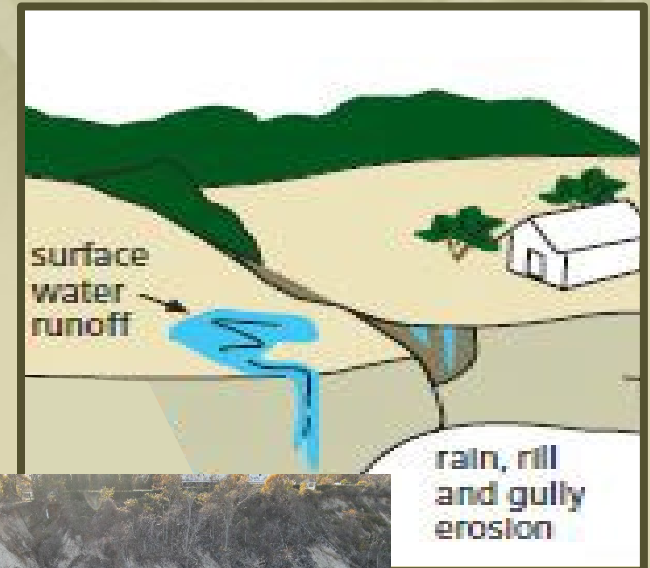
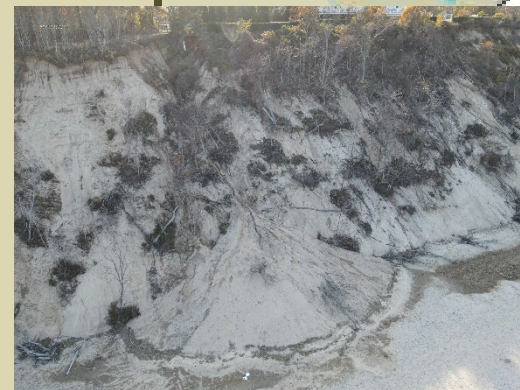
Secondary Form of Erosion:
Surface Runoff

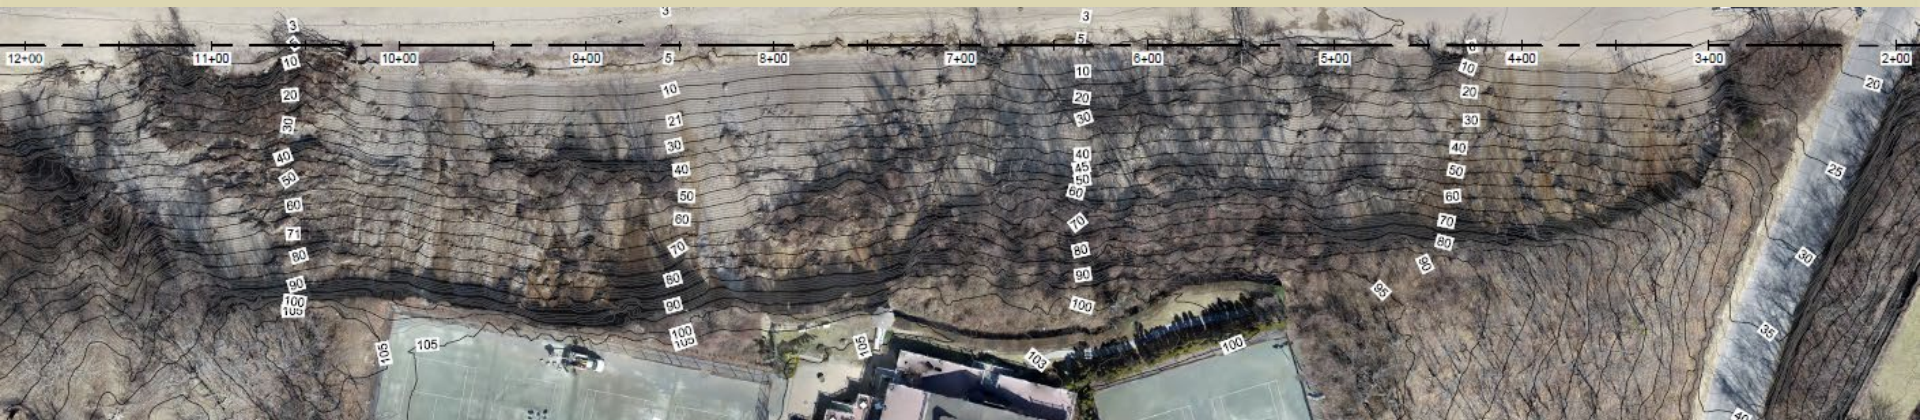
February 2018-March 2021 Bluff Recession Rate Analysis

Profile Line	Bluff Crest Recession Between 2018 and 2021 (LF)
3+00	15
4+00	.5
5+00	0
6+00	0
7+00	0
8+00	16.5
9+00	5
10+00	6
11+00	0
12+00	0
Average	4.3

Profile Line	Bluff Toe Recession Between 2018 and 2021 (LF)
3+00	7.5
4+00	15.5
5+00	6.5
6+00	8.5
7+00	3
8+00	8.5
9+00	16.5
10+00	15.5
11+00	8.5
12+00	16.5
Average	10.65

- ~30,700 cubic yards lost from Buff (February 2018- March 2021)
- ~1,700 dump truck loads

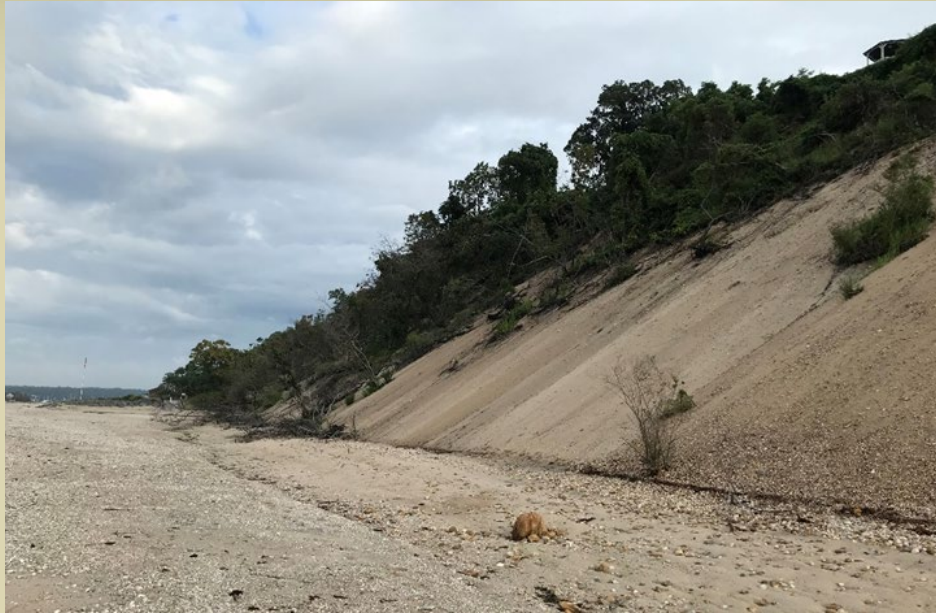
PRE- HURRICANE IDA

More Recent Bluff Loss

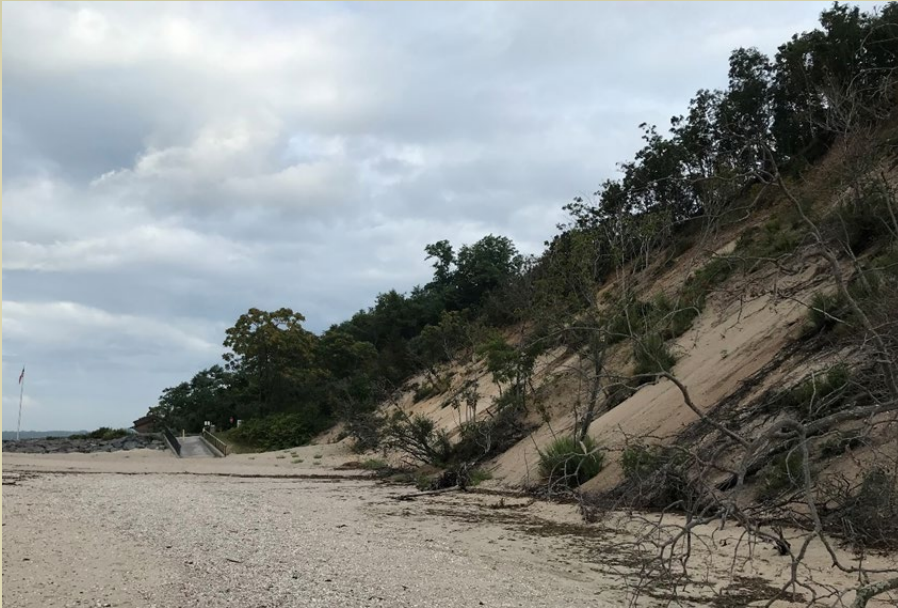
PRE- HURRICANE IDA

More Recent Bluff Loss

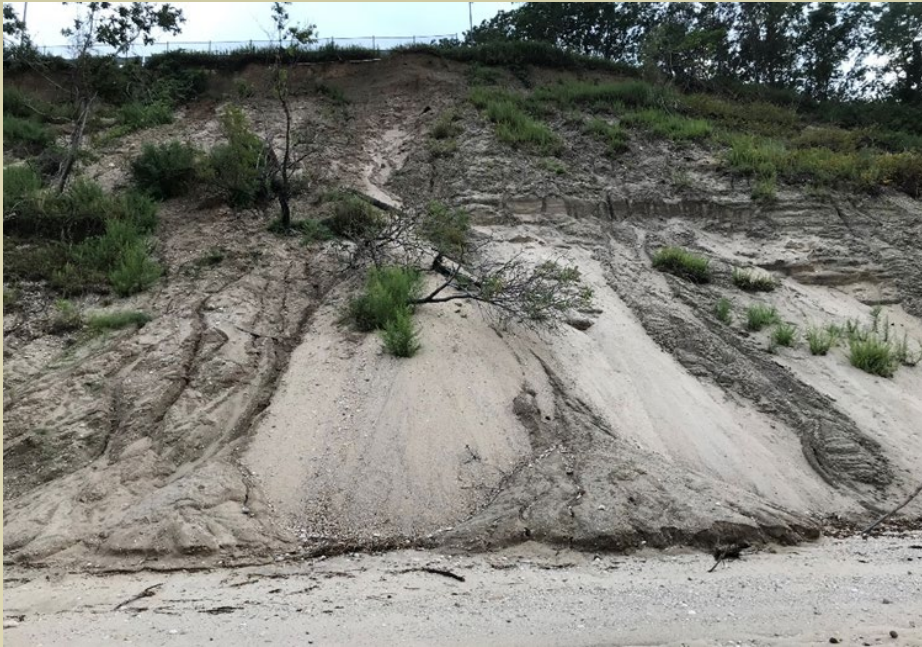
PRE- HURRICANE IDA

More Recent Bluff Loss
