VILLAGE OF PORT JEFFERSON EAST BEACH BLUFF STABILIZATION

Village Trustee Meeting: February 22, 2022

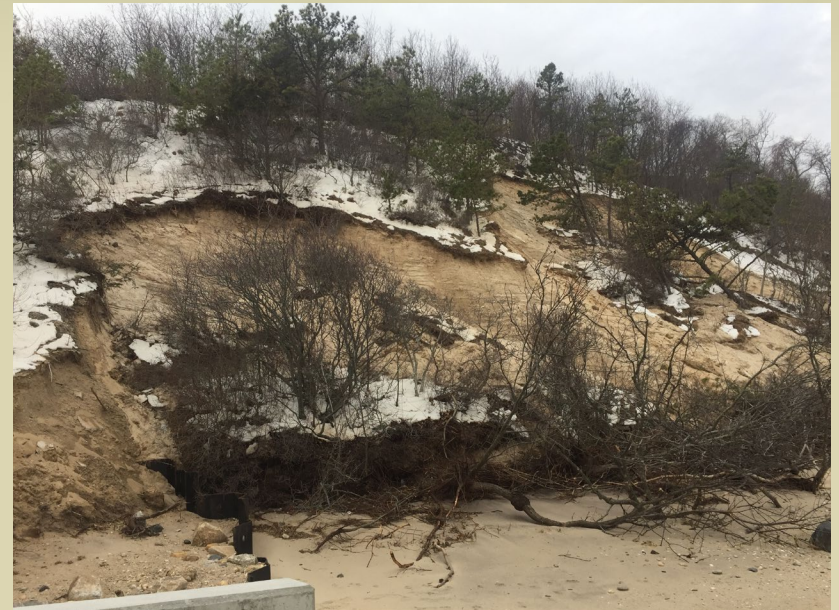
Spring of 2015

Winter of 2017

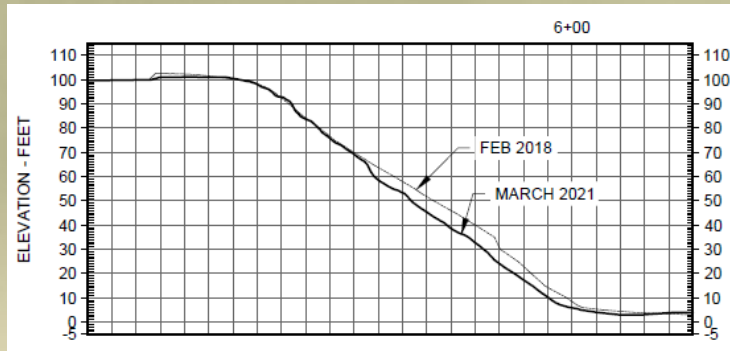
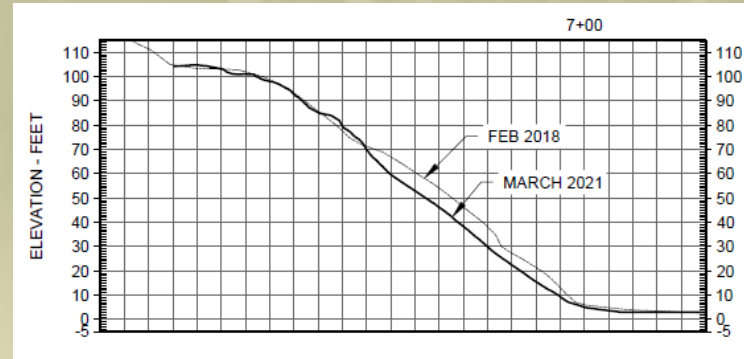
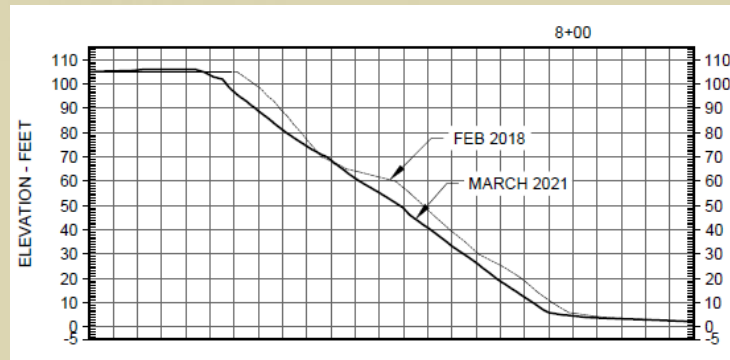
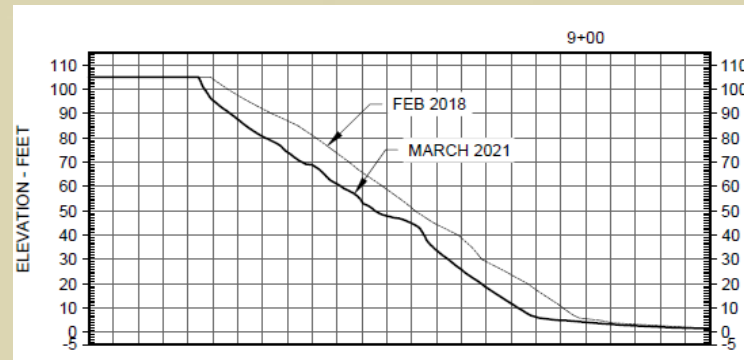
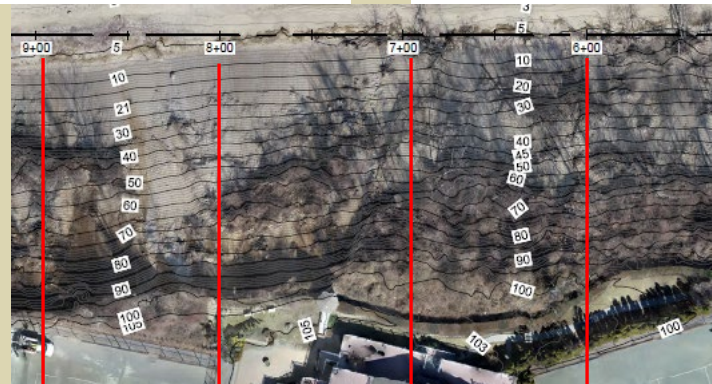
February 2018-March 2021 Bluff Recession Rate Analysis

Profile Line	Bluff Crest Recession Between 2018 and 2021 (LF)
3+00	15
4+00	.5
5+00	0
6+00	0
7+00	0
8+00	16.5
9+00	5
10+00	6
11+00	0
12+00	0
Average	4.3

Profile Line	Bluff Toe Recession Between 2018 and 2021 (LF)
3+00	7.5
4+00	15.5
5+00	6.5
6+00	8.5
7+00	3
8+00	8.5
9+00	16.5
10+00	15.5
11+00	8.5
12+00	16.5
Average	10.65

- ~30,700 cubic yards lost from Buff (February 2018- March 2021)
- ~1,700 dump truck loads
